MARITIME HERITAGE MINNESOTA

Ann Merriman
Christopher Olson

Andy Gibson Starboard Gunwale and Deck Excavation

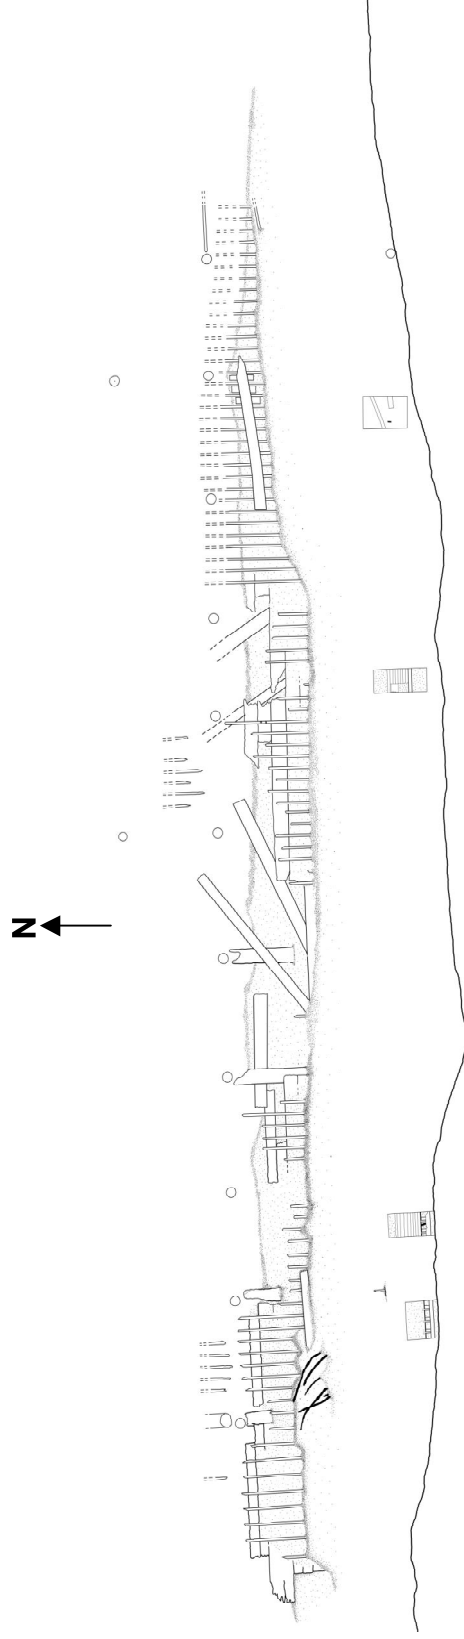
The MHM site plan for the *Andy Gibson* wreck site incorporating data from 2008-2011.

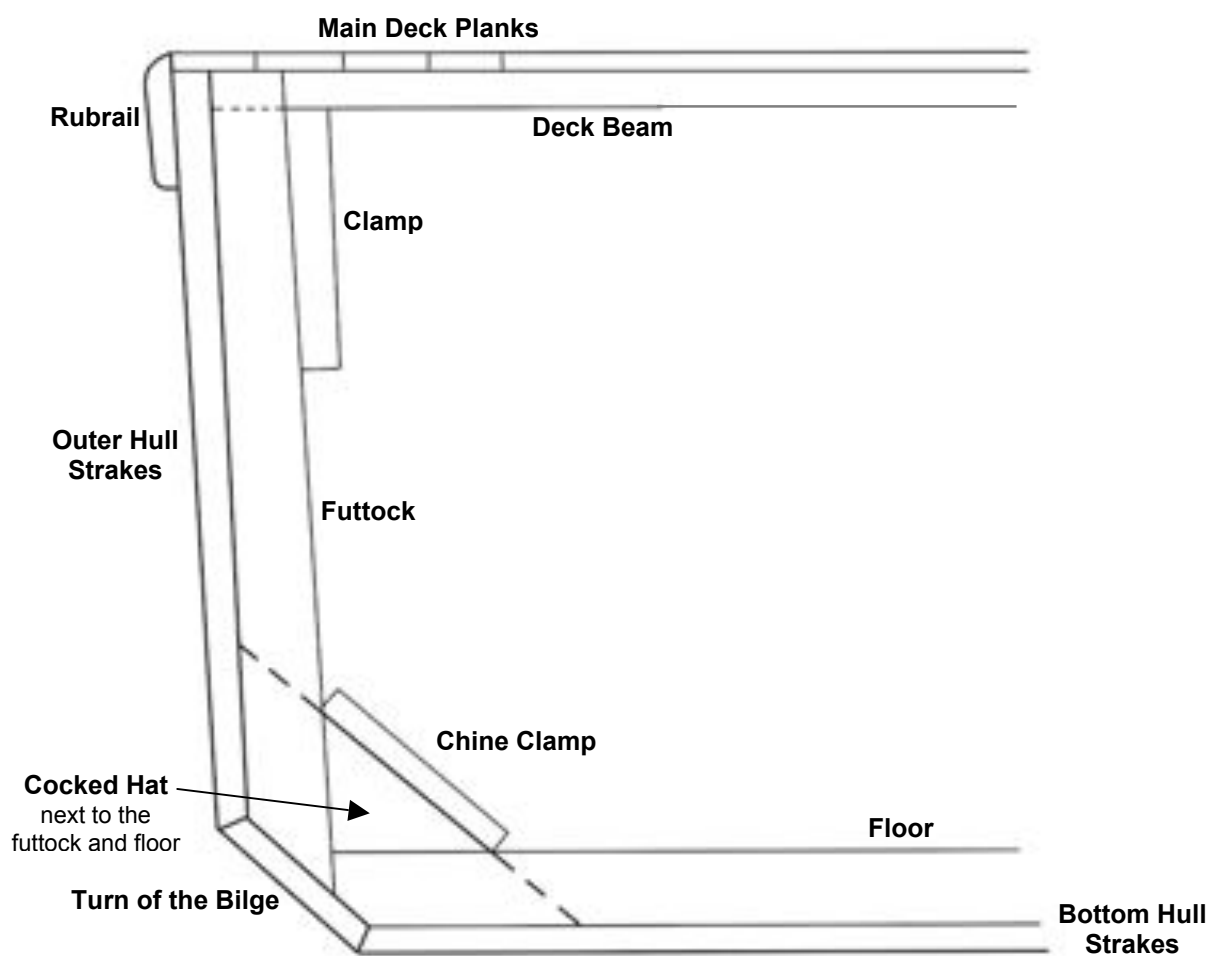
Appendix 1: Amidships Hull Cross-Section

This cross-section shows the nearly vertical sides of the hull near the center of the *Andy Gibson*. The hull would flare outward toward the bow.
